## Pre-drilled installation 2019 -current Chevy 1500 Single Rear Wheel Mud Flaps

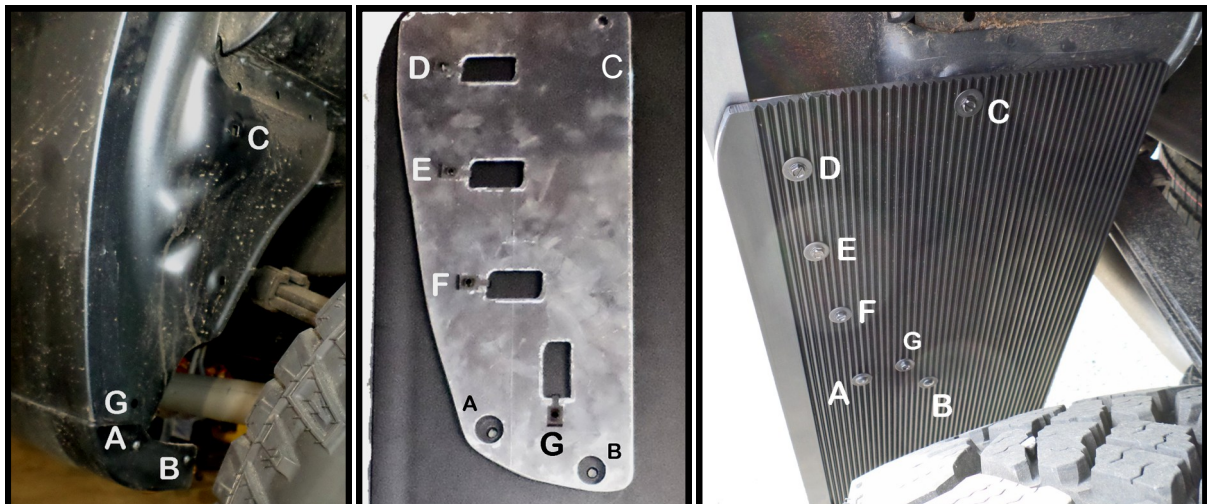
CR12 19 1500 CR12 22 1500 ZR2 2- (2019 1500 Chevy Brackets #10026)

**Hardware:** 10- #10x 1.25 Stainless Steel Black Oxide (SSBO) screws; 14- #10 (SSBO) washers;  
6- #8 x 1.25 (SSBO) screws; 2- plastic white nuts; 2- small plastic round spacers.  
**2- (2019 1500 Chevy Brackets) Aluminum flat brackets #10026; 8 small u-clips attached to brackets.**

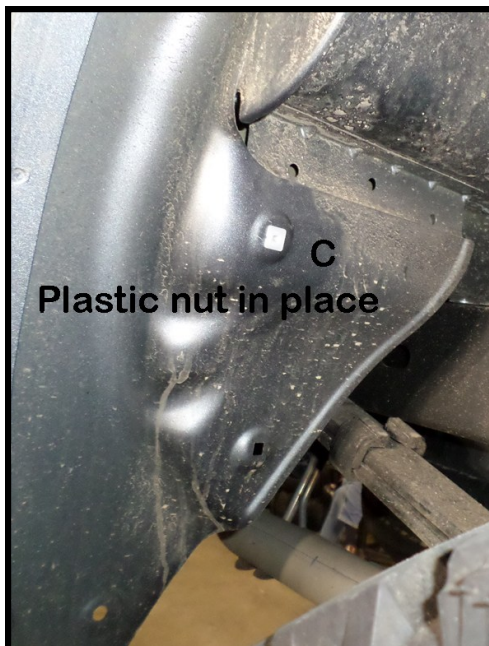
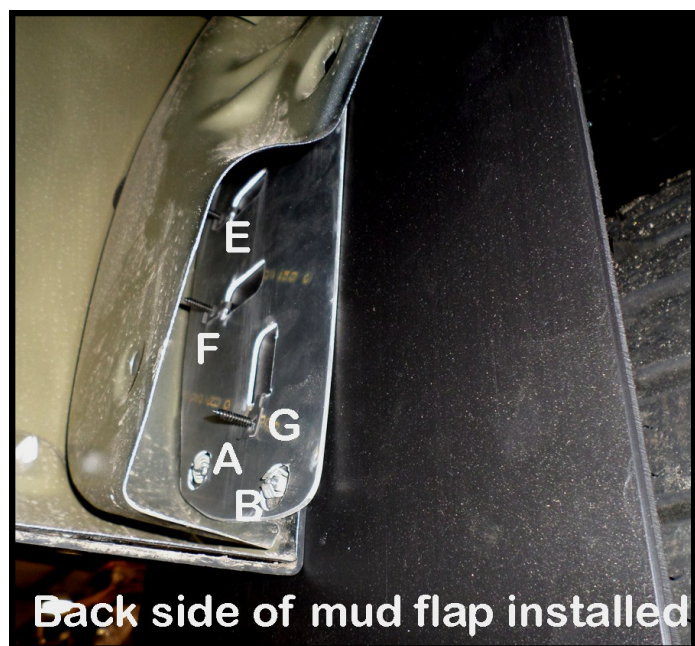
Step 2: Remove factory screws at point A and B.

Step 4: Attach the bracket to the back (smooth) side of the mud flap at points D,E and F.

Step 5: Insert the white plastic nut into the factory hole at point C. It will just push into place.

Step 6: Slip the edge of the bracket behind the fender well lip and over the factory clips at points A and B.

Step 8: Attach the mud flap at point C with a #10 Screw thru washer - Mudflap - Spacer - Bracket - supplied white nut. Use a # 8 screw if you have a factory nut insert installed from factory.

Step 9: Secure point G with a #10 Screw & washer. Leave slightly loose.

Step 10: Check alignment and tighten in order A, B, C. Then tighten D, E, F, G just enough to form the flap to the fender well.
